**Flood Control Project Maintenance
Levee Inspections**

Fall 2013 Levee Maintenance Deficiency Summary Report

Sacramento River Basin

Sutter Maintenance Yard Maintenance Area 0013

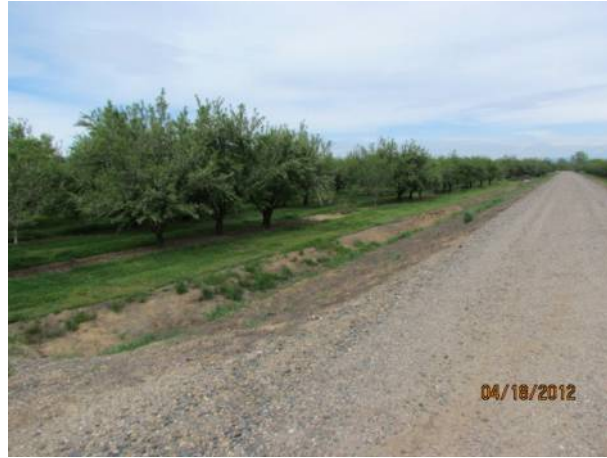
rduffey_f_20130919_808.JPG

View of the vehicle erosion along the waterside slope.

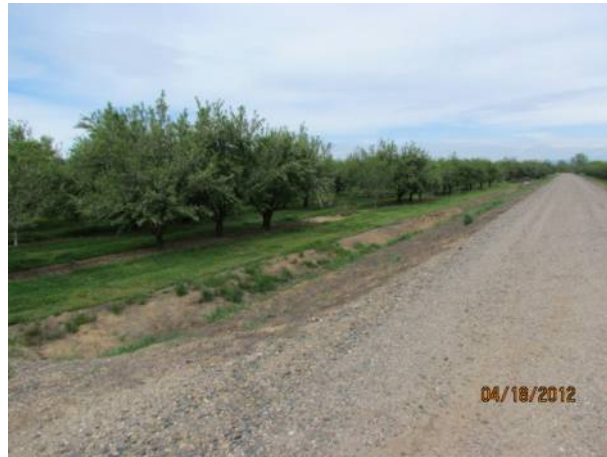
Levee Mile Report Line	9
Start Levee Mile	0.66
End Levee Mile	1.20
Location	Land Side
Category	Earthen Levee
Item	Encroachments

View of the agricultural ditch along the toe of the levee.

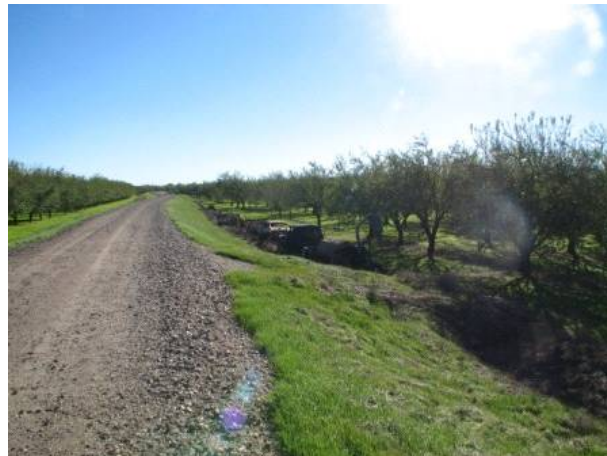
Levee Mile Report Line	10
Start Levee Mile	0.76
End Levee Mile	0.78
Location	Land Side
Category	Earthen Levee
Item	Encroachments

View of the equipment along the landside toe of the levee.

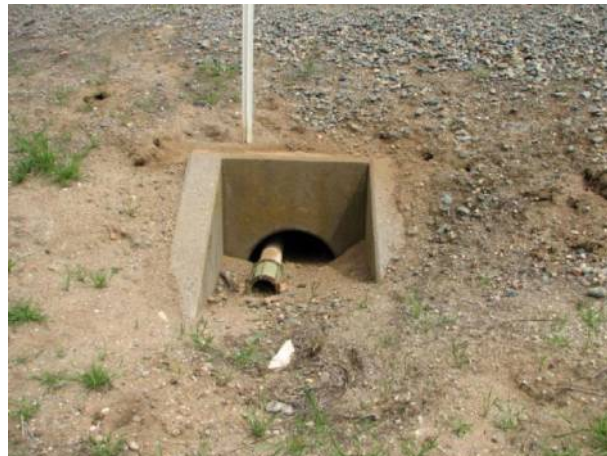
UCIP_66.jpg

Apr 2012 - LS view of crossing. Approximately 50 % of the inlet is blocked with sediment.

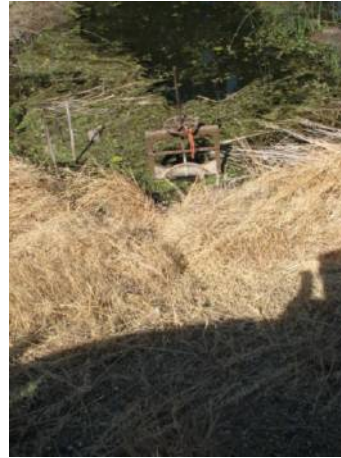
UCIP_947.jpg

Limit view of LS slope due to vegetation.

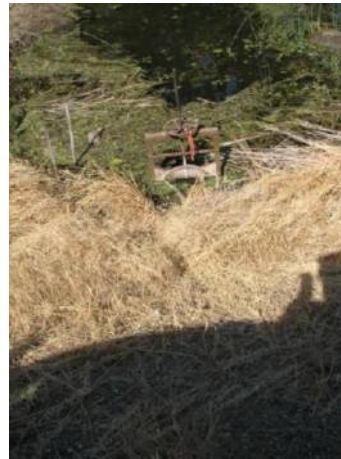
Levee Mile Report Line	101
Start Levee Mile	3.78
End Levee Mile	3.78
Location	Land Side
Category	Supplemental
Item	DWR UCIP Field Study

Limit view of LS slope due to vegetation.

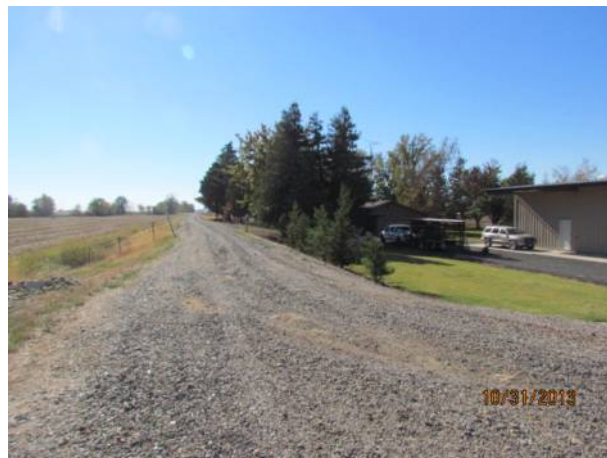
Levee Mile Report Line	121
Start Levee Mile	4.13
End Levee Mile	4.20
Location	Land Side
Category	Earthen Levee
Item	Encroachments

View of the redwood trees along the landside slope.

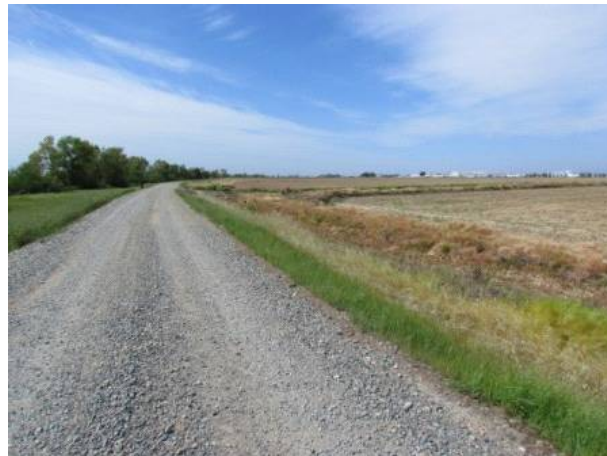
Levee Mile Report Line	175
Start Levee Mile	6.51
End Levee Mile	7.09
Location	Land Side
Category	Earthen Levee
Item	Encroachments

View of the agricultural ditch along the toe.

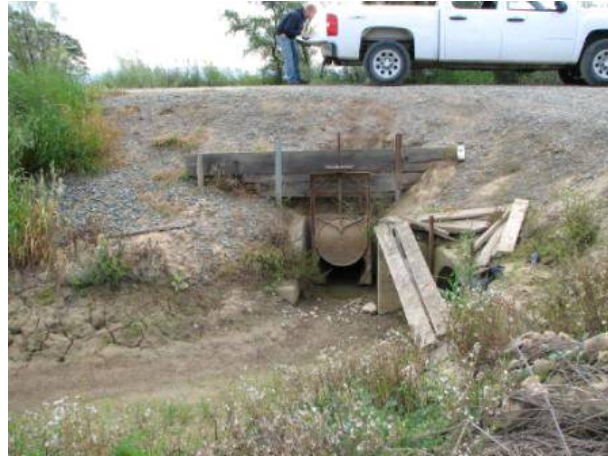
UCIP_1826.jpg

View of LS slide gate. Levee section missing behind boards.

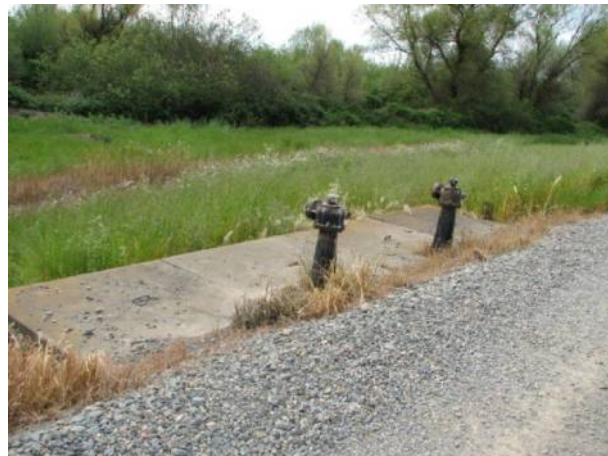
Levee Mile Report Line	192
Start Levee Mile	6.56
End Levee Mile	6.56
Location	Land Side
Category	Supplemental
Item	DWR UCIP Field Study

Evidence of 72 inch lines are buried on WS slope.

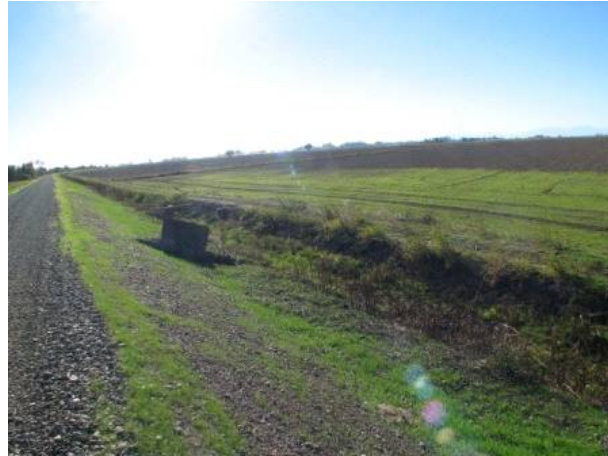
rduffey_s_20120312_320.jpg

View of a concrete block along the toe.

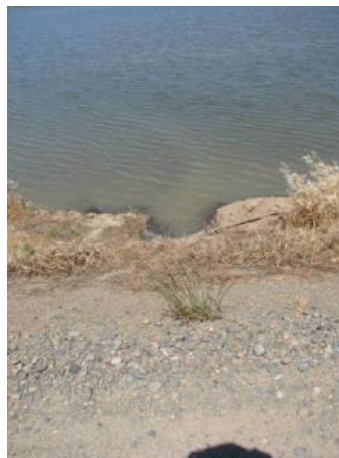
Levee Mile Report Line	231
Start Levee Mile	8.40
End Levee Mile	8.40
Location	Land Side
Category	Supplemental
Item	DWR UCIP Field Study

View of LS slope and toe (flooded farm)

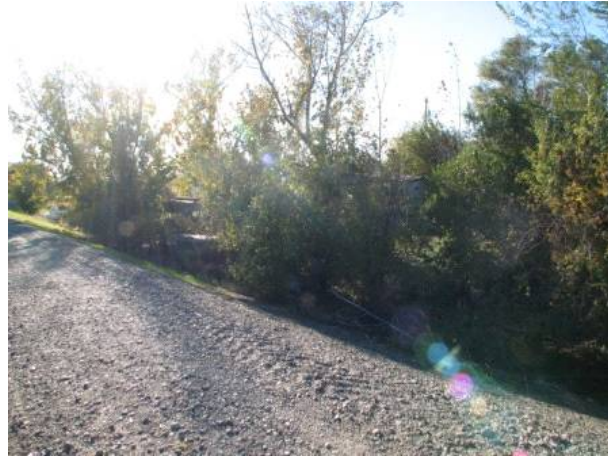
rduffey_s_20120312_323.jpg

View of trees that need to be trimmed along the toe.

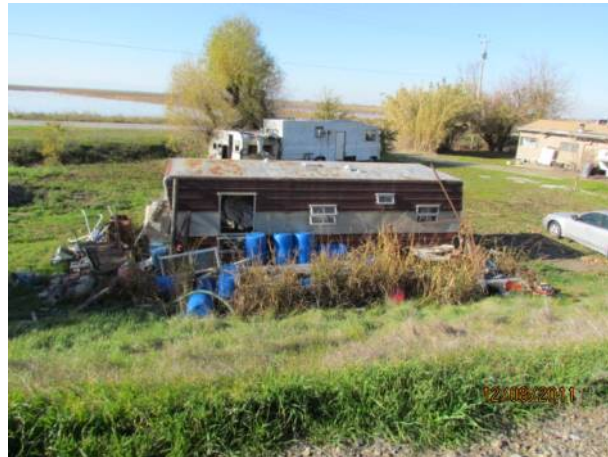
Levee Mile Report Line	262
Start Levee Mile	9.89
End Levee Mile	9.89
Location	Land Side
Category	Earthen Levee
Item	Encroachments

View of a trailer & material along the L/S toe.

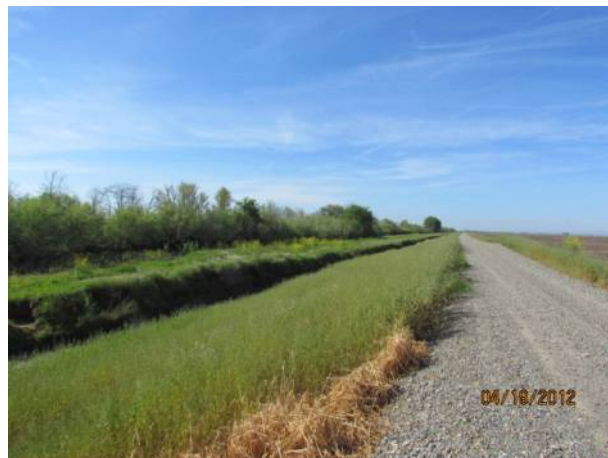
Levee Mile Report Line	263
Start Levee Mile	11.20
End Levee Mile	13.47
Location	Water Side
Category	Earthen Levee
Item	Encroachments

View of the agricultural ditch along the toe of the levee.

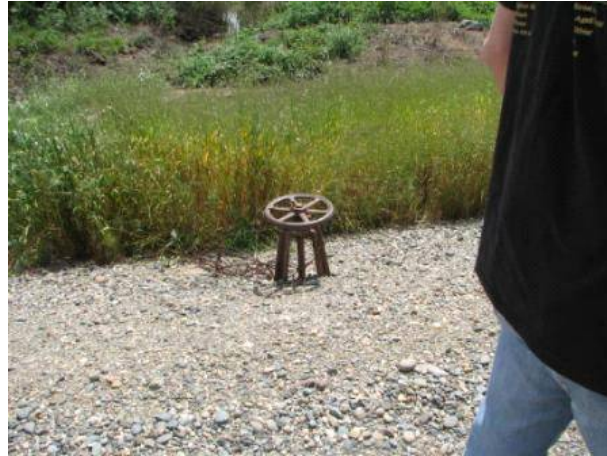
UCIP_2348.jpg

Buried slide gate on the WS slope.

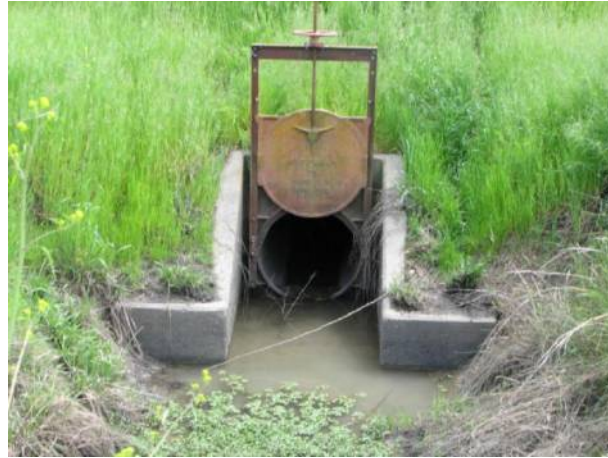
UCIP_8825.jpg

Slide gate located on LS toe. Dense vegetation present on LS slope.

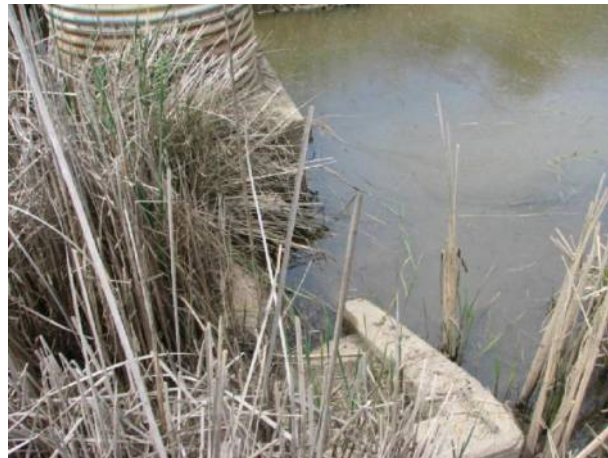
Levee Mile Report Line	315
Start Levee Mile	15.95
End Levee Mile	15.95
Location	Land Side
Category	Supplemental
Item	DWR UCIP Field Study

Headwall and standpipe on LS. Limited visibility of headwall due to dense vegetation.

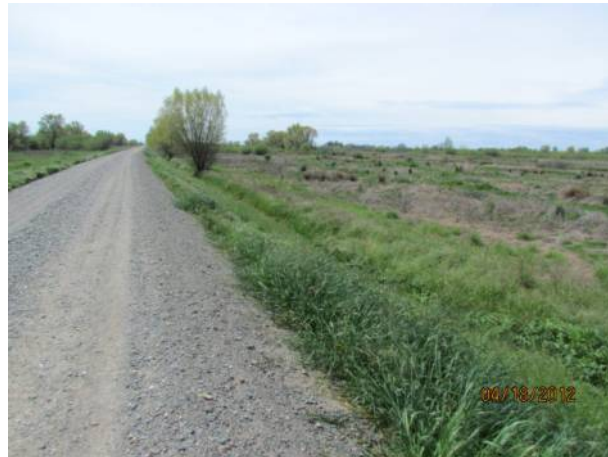
rduffey_s_20120430_605.jpg

View of the ag along the toe of the levee.

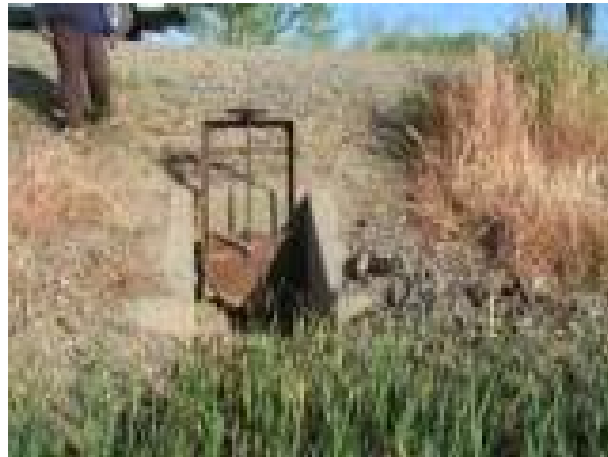
UCIP_1352.jpg

View of LS slide gate. Sediment deposit near gate.

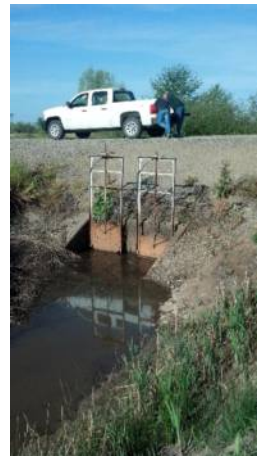
UCIP_91.jpg

Headwall and screw gates (2) located on land side of levee. Missing handle on screw gate 1 of 2.

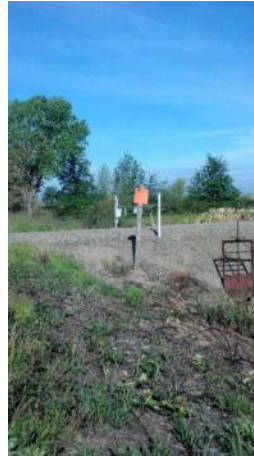
Levee Mile Report Line	52
Start Levee Mile	2.64
End Levee Mile	2.64
Location	Water Side
Category	Supplemental
Item	DWR UCIP Field Study
View of slide gate looking upstream. Utility line downstream next to this crossing.	
UCIP_8257.jpg

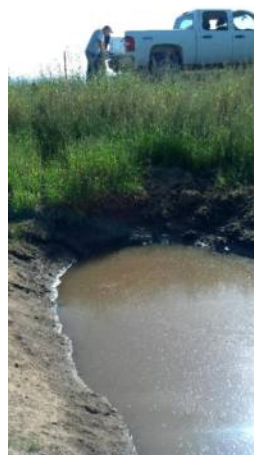
Levee Mile Report Line	63
Start Levee Mile	3.61
End Levee Mile	3.61
Location	Water Side
Category	Supplemental
Item	DWR UCIP Field Study
Flap gate submerged in water on WS of levee	
UCIP_101.jpg

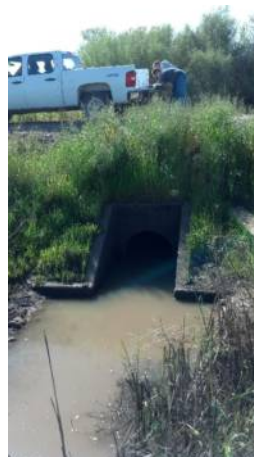
Levee Mile Report Line	89
Start Levee Mile	3.86
End Levee Mile	3.86
Location	Water Side
Category	Supplemental
Item	DWR UCIP Field Study
On the LS unable to evaluate the LS slope around headwall due to dense vegetation.	
UCIP_8301.jpg

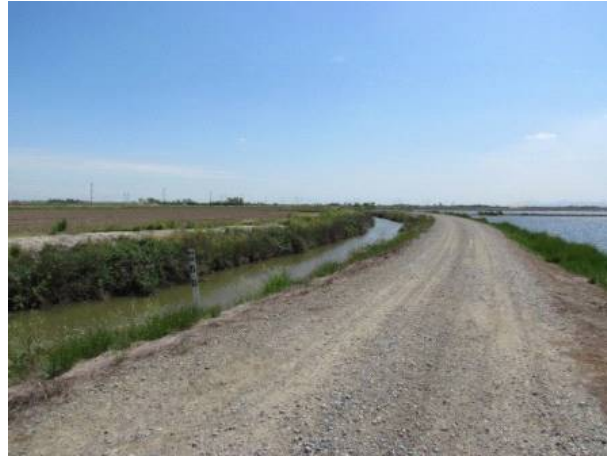
rduffey_s_20120312_341.jpg

View of agricultural ditch along the toe.

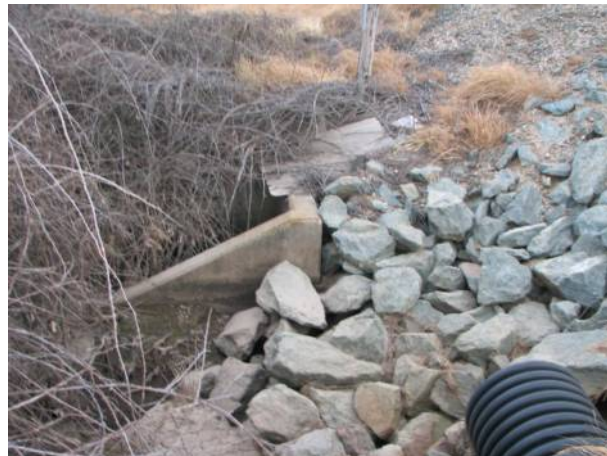
UCIP_122.jpg

View of side profile of LS headwall. Exposed headwall and possible erosion occurring behind headwall repaired by dumping rip rap.

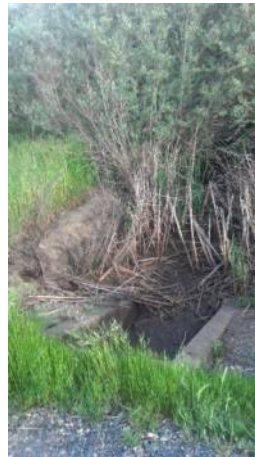
UCIP_592.jpg

View of WS headwall with dense vegetation in channel.

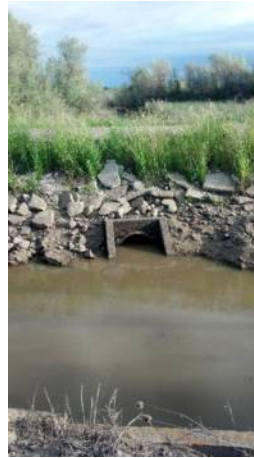
UCIP_129.jpg

Headwall and damaged/missing screw gate on land side of levee

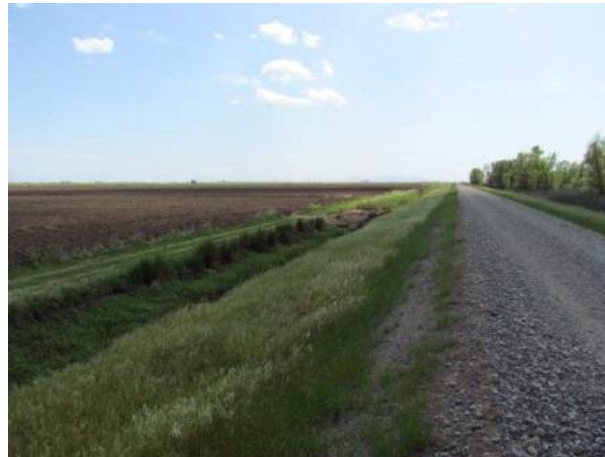
rduffey_s_20120312_334.jpg

View of the agricultural ditch along the toe.

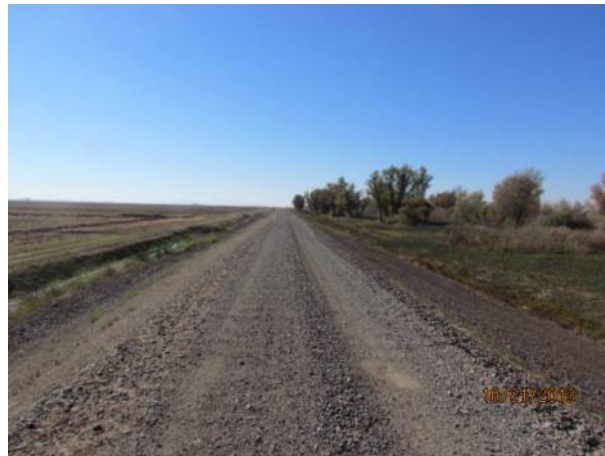
rduffey_f_20131118_148.JPG

View of the burned and dragged slopes.

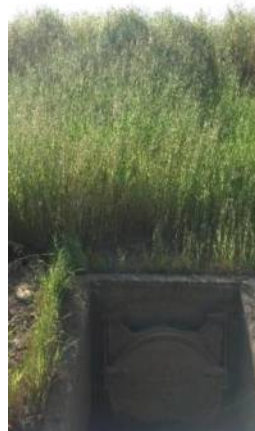
UCIP_2306.jpg

WS view of crossing. Dense vegetation along WS slope limited visual inspection. (WS Photo 2 of 2)

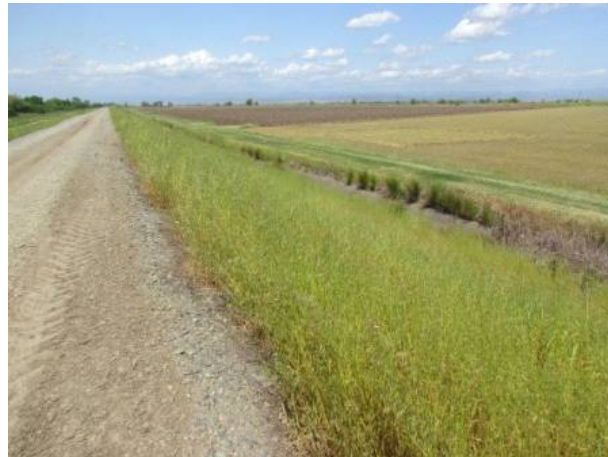
rduffey_s_20120312_335.jpg

View of the agricultural ditch along the toe.

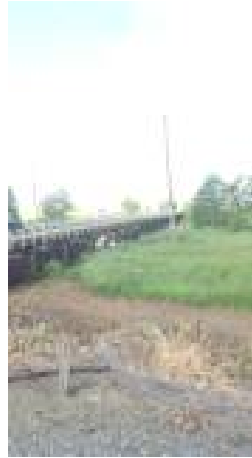
UCIP_1535.jpg

Pole within the channel was not removed.

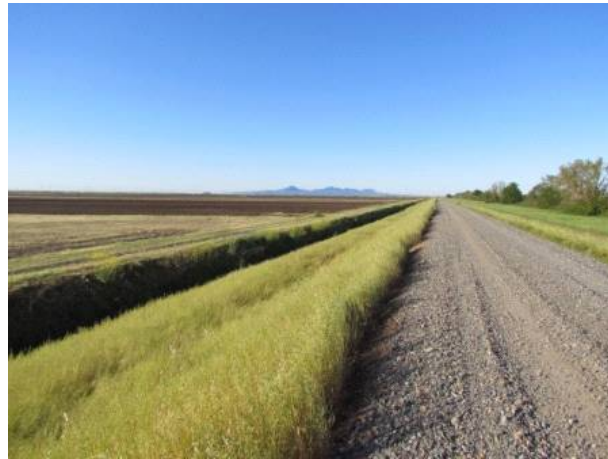
rduffey_s_20120312_337.jpg

View of the agricultural ditch along the toe.

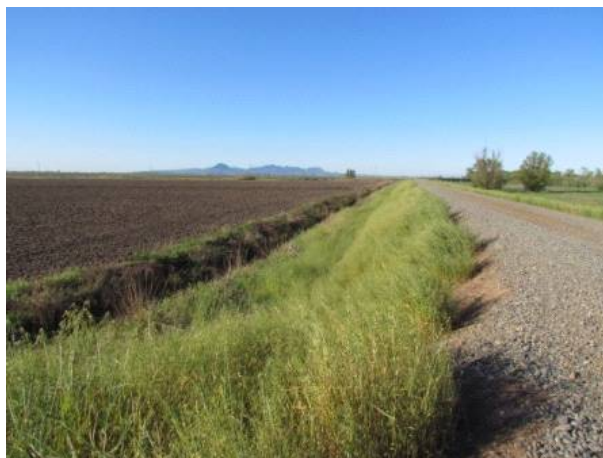
rduffey_s_20120312_338.jpg

View of the agricultural ditch along the toe.

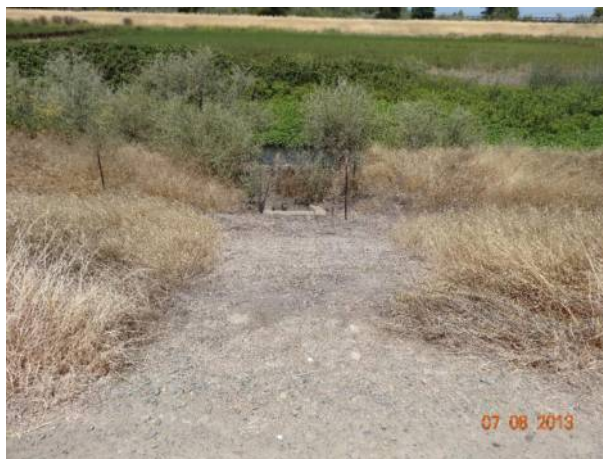
UCIP_8435.jpg

WS slope cleared of vegetation

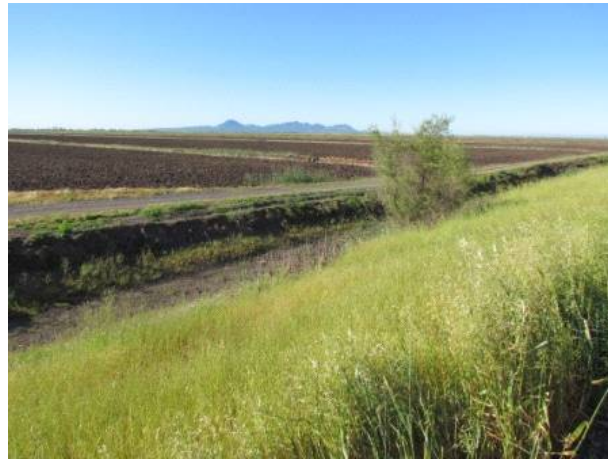
rduffey_s_20120312_339.jpg

View of the agricultural ditch along the toe.

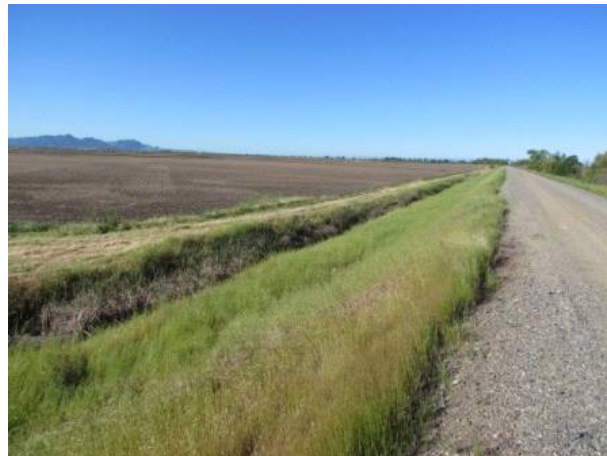
rduffey_s_20120312_340.jpg

View of the agricultural ditch along the toe.

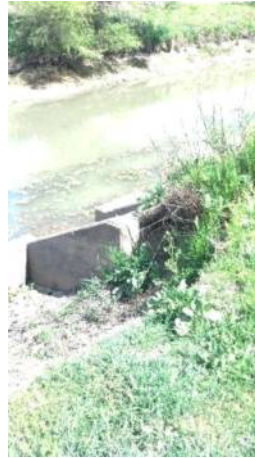
UCIP_162.jpg

Erosion behind WS headwall looking at the downstream edge of headwall.

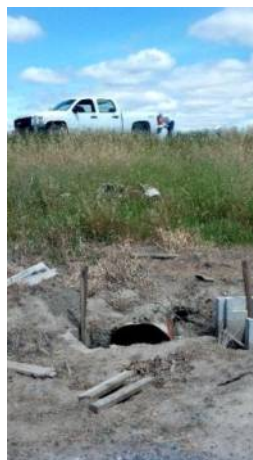
UCIP_190.jpg

View of LS slope and pipe inlet.

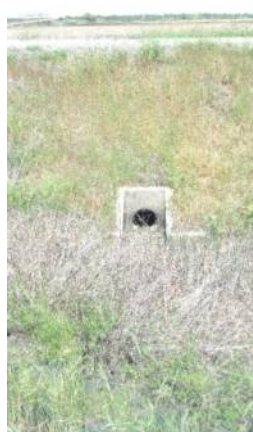
UCIP_2339.jpg

View of LS headwall.

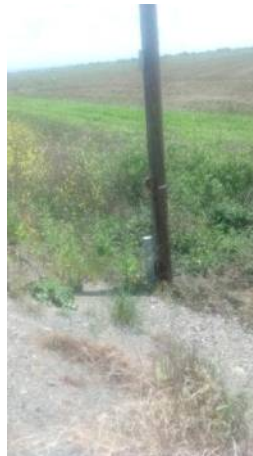
UCIP_237.jpg

View of utility line located on LS toe.

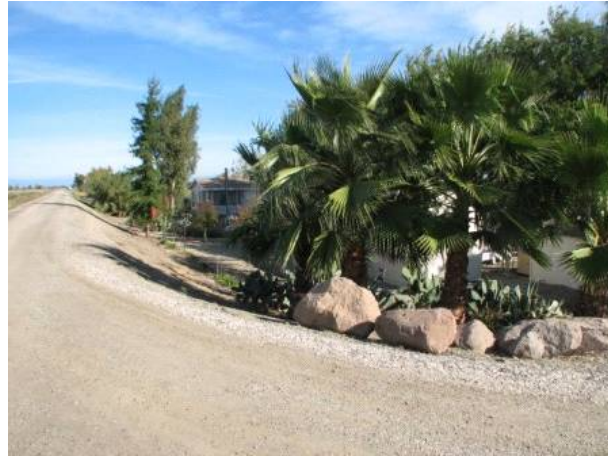
rduffey_s_20120312_329.jpg

View of landscaping along the toe.

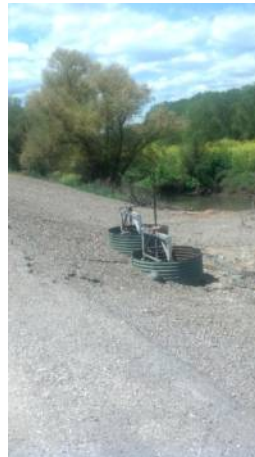
UCIP_8566.jpg

View of corrugated metal risers located on WS.

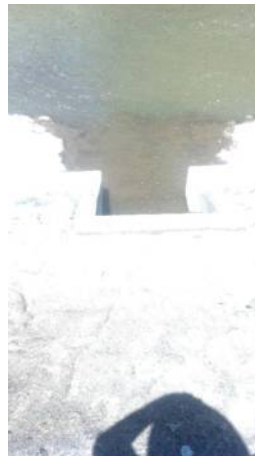
UCIP_8585.jpg

View of WS slope looking from WS headwall to levee crown.

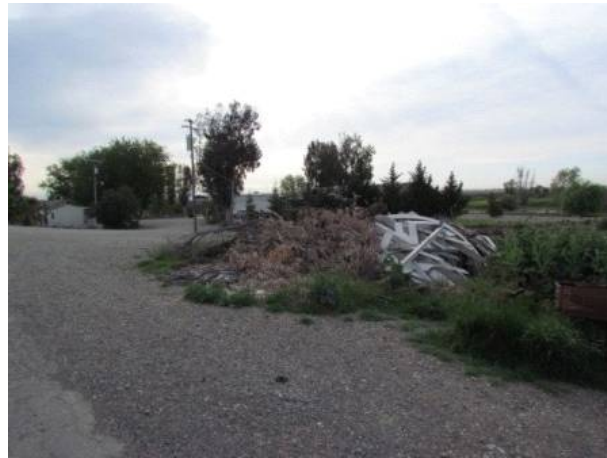
rduffey_s_20120312_331.jpg

View of the debris & prunings.

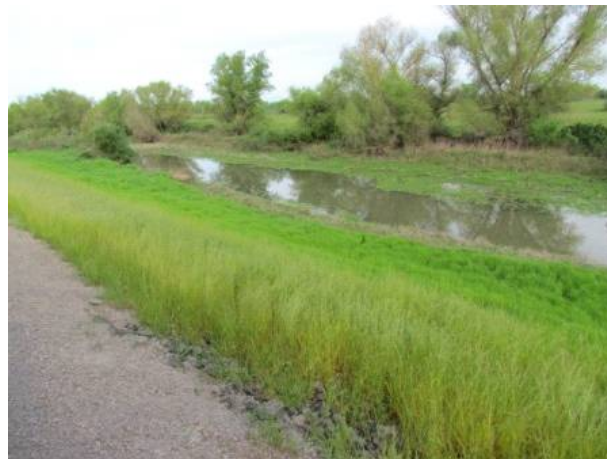
rduffey_s_20120312_330.jpg

View of the along the canal.
